## Section C Clayville Industrial – Water infrastructure assessment

## 5. Main Road (Service Road):

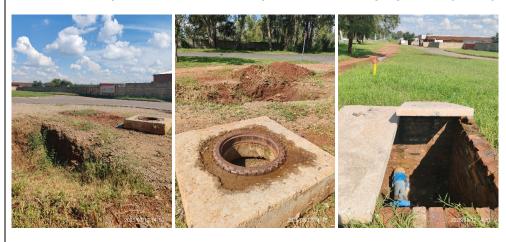
Excavation left open and infrastructure exposed – No warning signs or any safety measures in place.

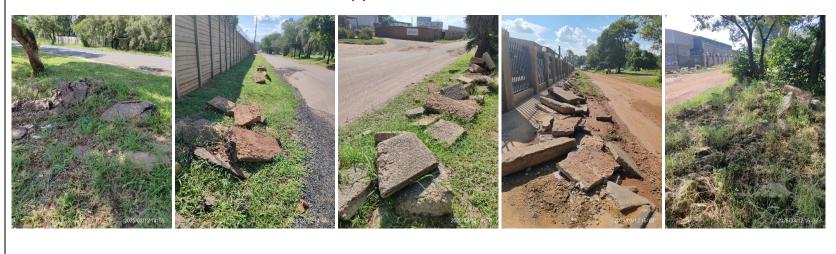
## Excavation material left after the installation of the water pipeline.

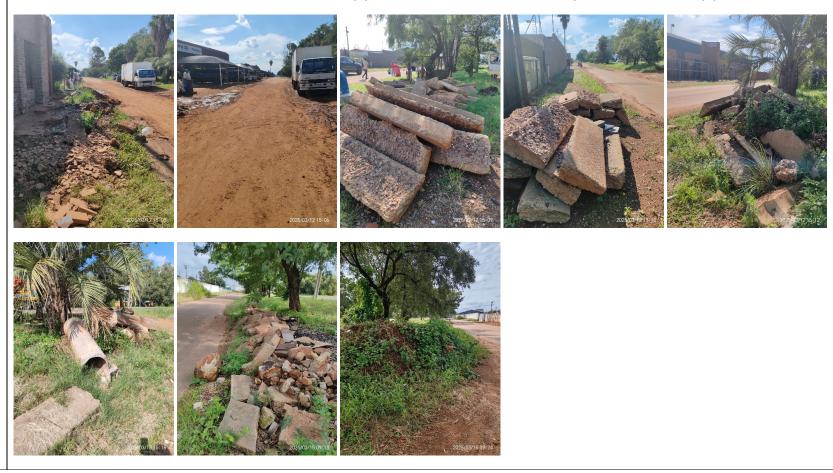
## Excavation material left after the installation of the water pipeline which also resulted in damage to the storm water pipeline.
