**Report to The City of Ekurhuleni**

**Infrastructure Maintenance & Service Request**  
**for**  
**Clayville Industrial**

**Pothole assessment report:**

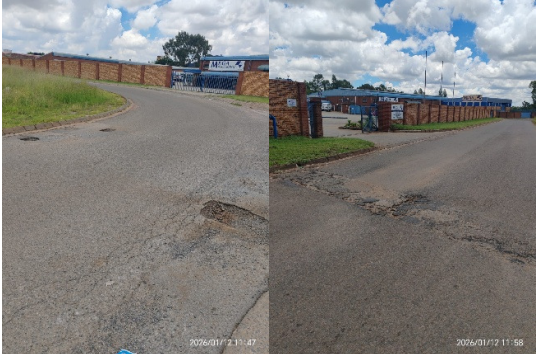
| 3.1 | | | Entrance Mega Packaging. |

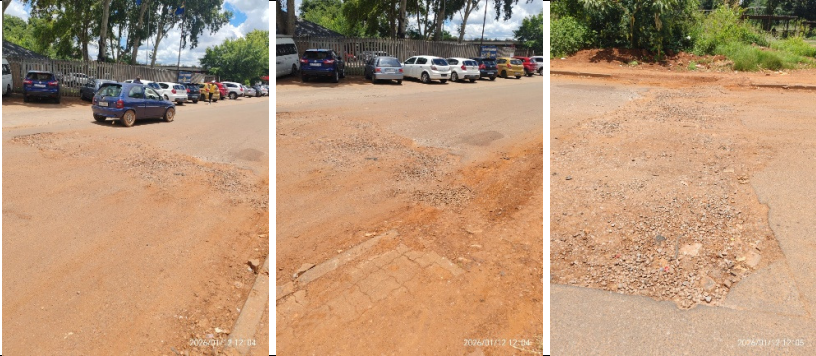
| 3.3 | | | <p>In front of Shell Garage and Police Station.</p> <p>Reinstatement of road required after repair of a burst water pipe.</p> |

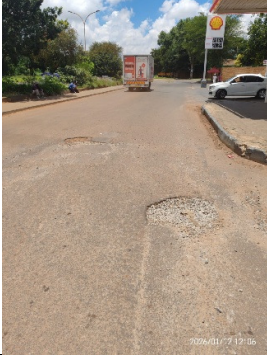
| 3.4 | | | At Shell Garage. |

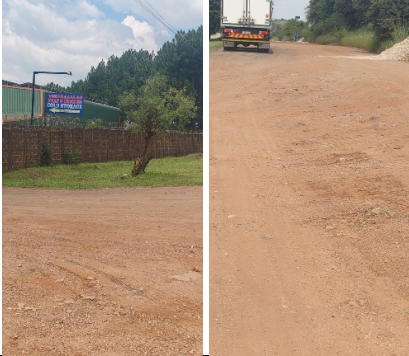
| 4.1 | | | | Road maintenace required. |

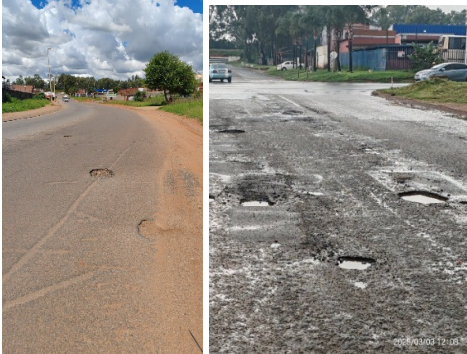
| 8.1 | | | Intersection of Nut & Industry Road. |

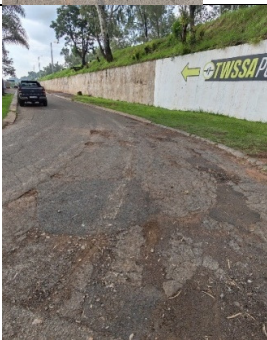
| 8.3 | | | Road surface maintenance required. |

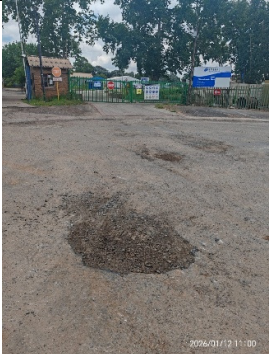
| 10.1 | | | | Entrance to 151 Pebble Lane |

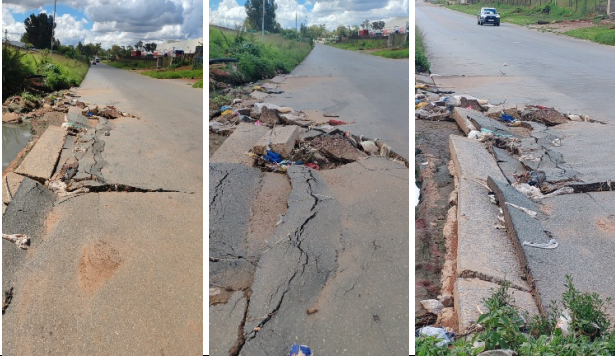
| 14.4 | | | At the collapsed portion of the water canal. |

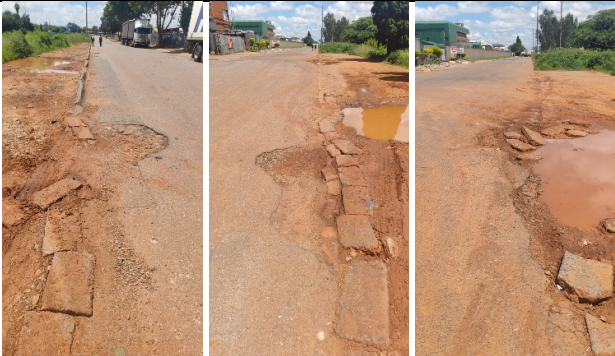
| 15.1 | | | Opposite SPAR DC entrance. |

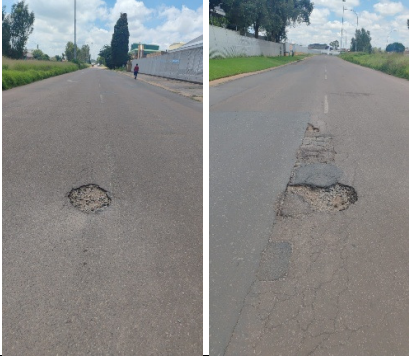
| 15.2 | | | | Near Clover factory shop. |

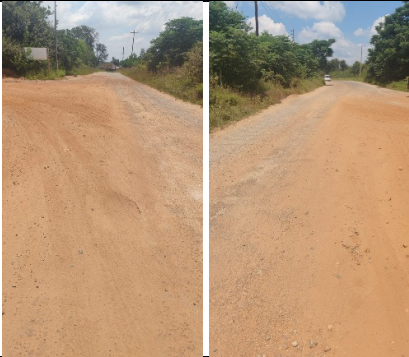
| 16.1 | | | | Entrance to Clayville East (Glenton Avenue).<br><br>Road clearing and maintenance required. |
